DEPARTMENT OF TRANSPORTATION

Contract #: 04-0120F4Cty: SF/ALA Rte: 80 PM: 13.2/13.9File #: 69.28**WELDING INSPECTION REPORT****Resident Engineer:**Pursell, Gary**Address:** 333 Burma Road**City:** Oakland, CA 94607**Report No:** WIR-010379**Date Inspected:** 20-Oct-2009**Project Name:** SAS Superstructure**OSM Arrival Time:** 700**Prime Contractor:** American Bridge/Fluor Enterprises, a JV**OSM Departure Time:** 1900**Contractor:** Zhenhua Port Machinery Company, Ltd (ZPMC), Changxing Island **Location:** Shanghai, China**CWI Name:** Li Yang**CWI Present:** Yes No**Inspected CWI report:** Yes No N/A**Rod Oven in Use:** Yes No N/A**Electrode to specification:** Yes No N/A**Weld Procedures Followed:** Yes No N/A**Qualified Welders:** Yes No N/A**Verified Joint Fit-up:** Yes No N/A**Approved Drawings:** Yes No N/A**Approved WPS:** Yes No N/A**Delayed / Cancelled:** Yes No N/A**Bridge No:** 34-0006**Component:** OBG Crossbeams and subassemblies**Summary of Items Observed:**

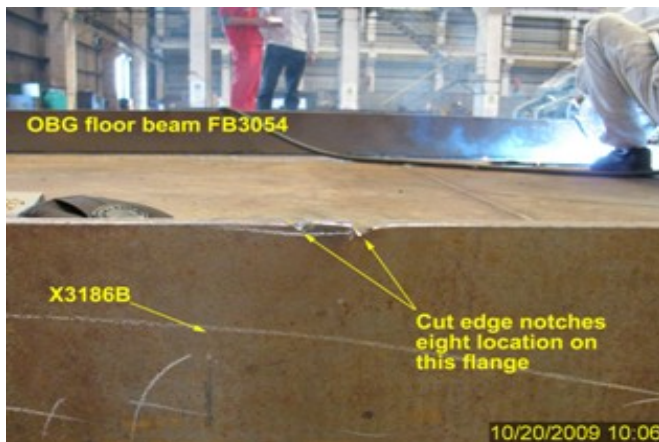
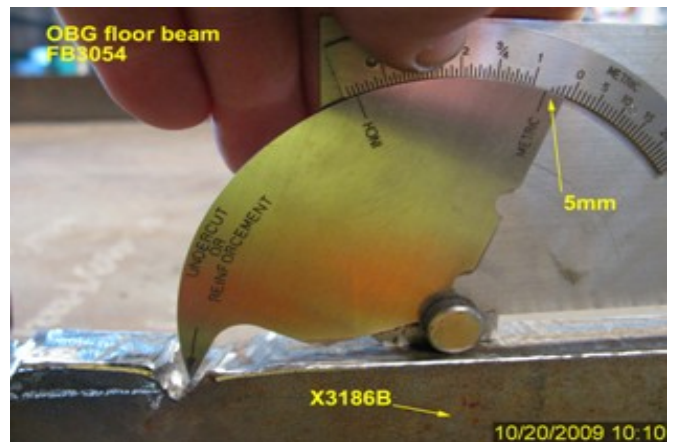
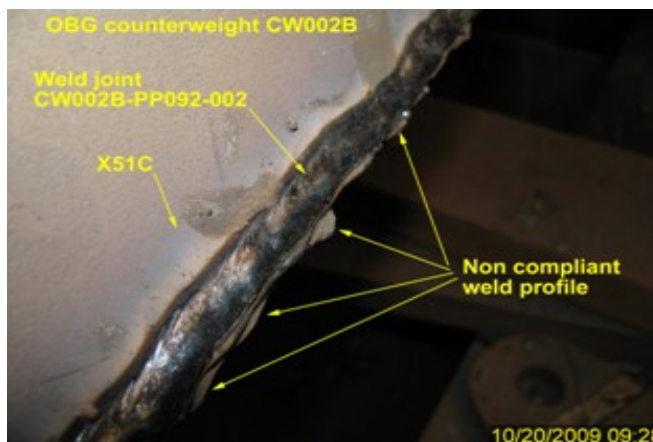
During random visual inspection of floor beam FB3054A this QA observed various cut edge notches 4mm to 5mm in depth. These notches were observed on both edges of pcmk X3186B. The attached photos of these notches are intended to capture the in-process workmanship being performed on this component.
